Letter of Notification for the Cyprus 345 kV Extension Project

PUCO Case No. 24-0175-EL-BLN

Submitted by:
AEP Ohio Transmission Company, Inc.

March 14, 2024

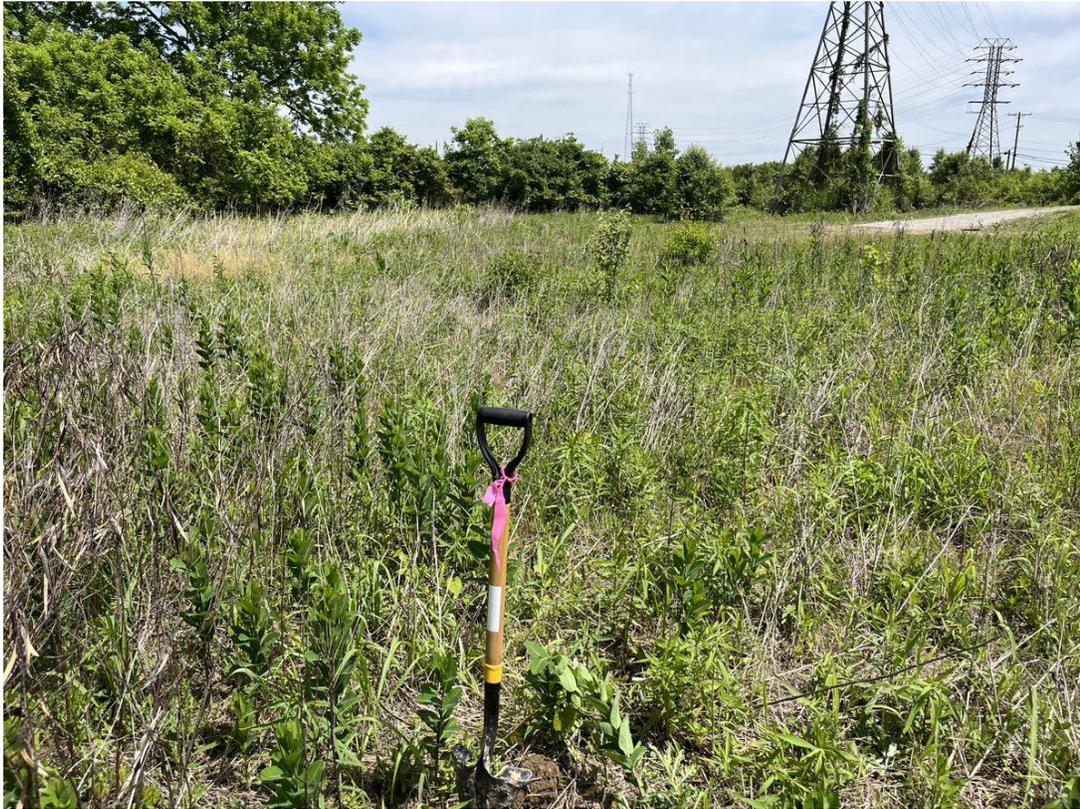
PHOTOGRAPH 1

Soil Test Pit STP-001, facing north on May 25, 2023.

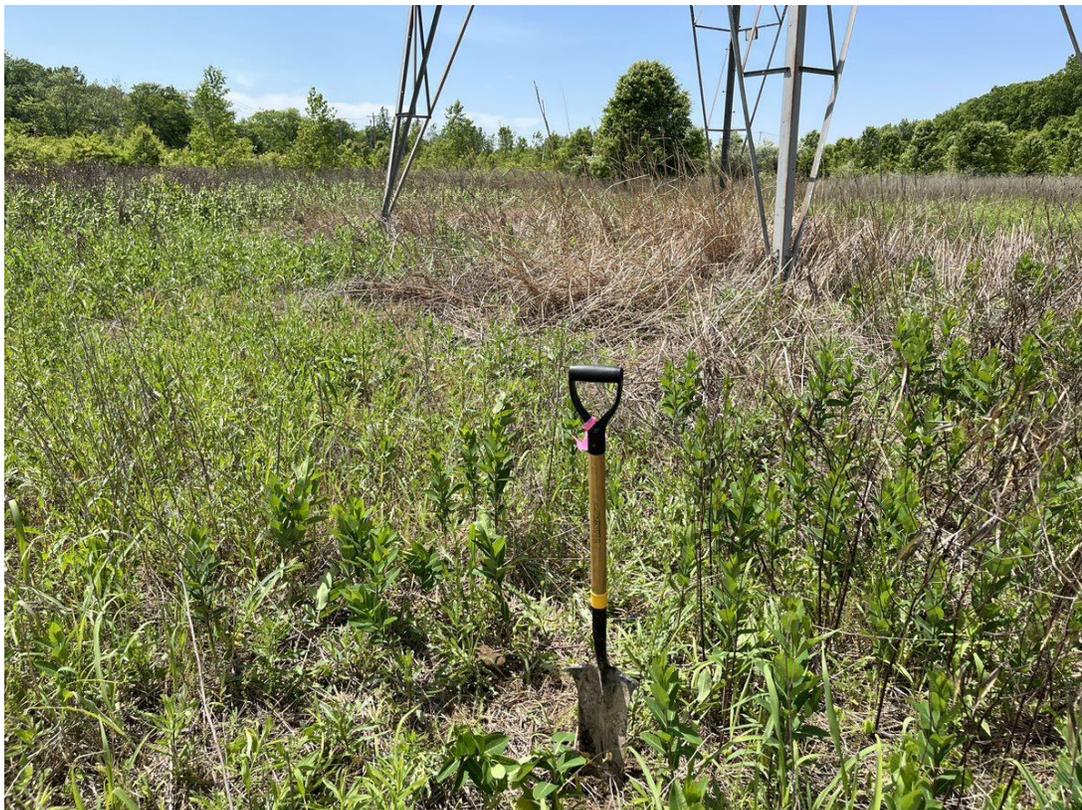
PHOTOGRAPH 2

Soil Test Pit STP-001, facing south on May 25, 2023.

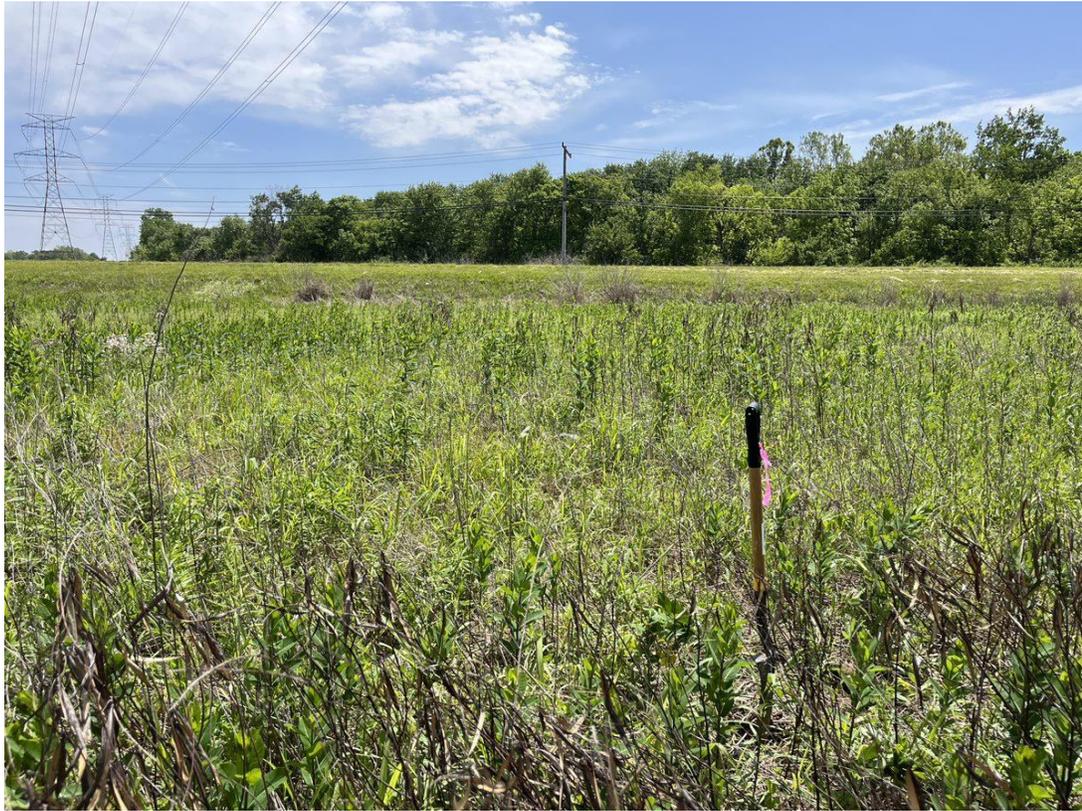
PHOTOGRAPH 3

Soil Test Pit STP-001, facing east on May 25, 2023.

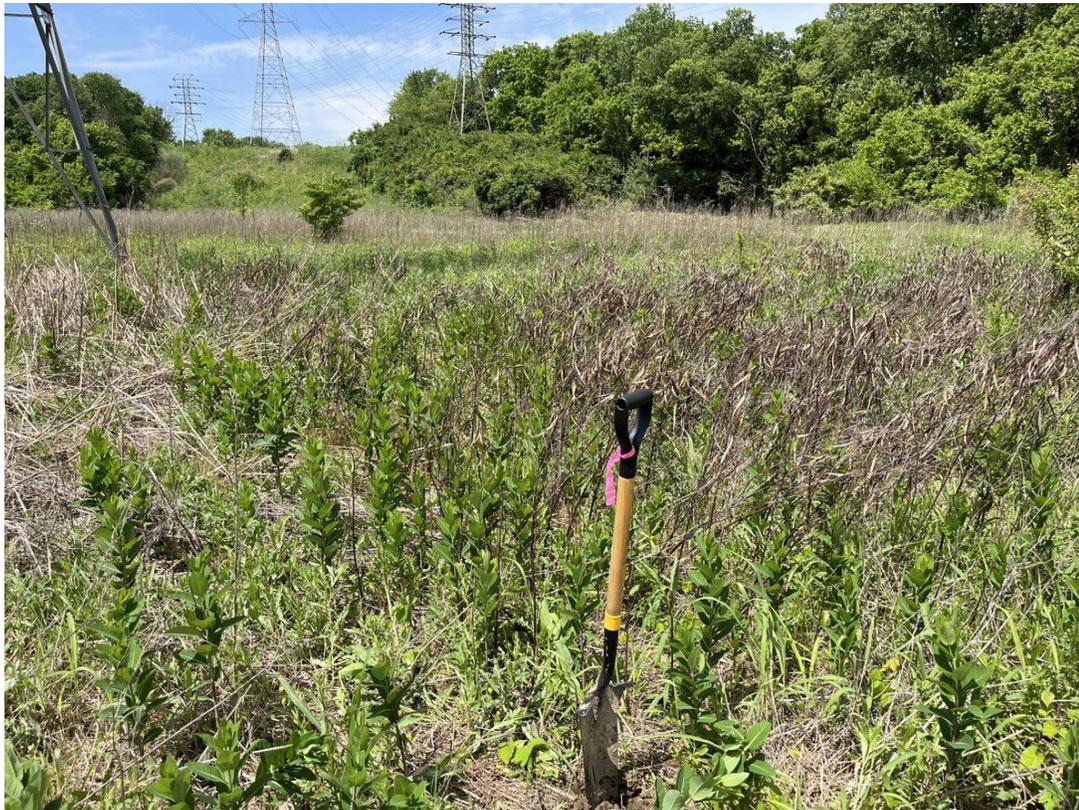
PHOTOGRAPH 4

Soil Test Pit STP-001, facing west on May 25, 2023.

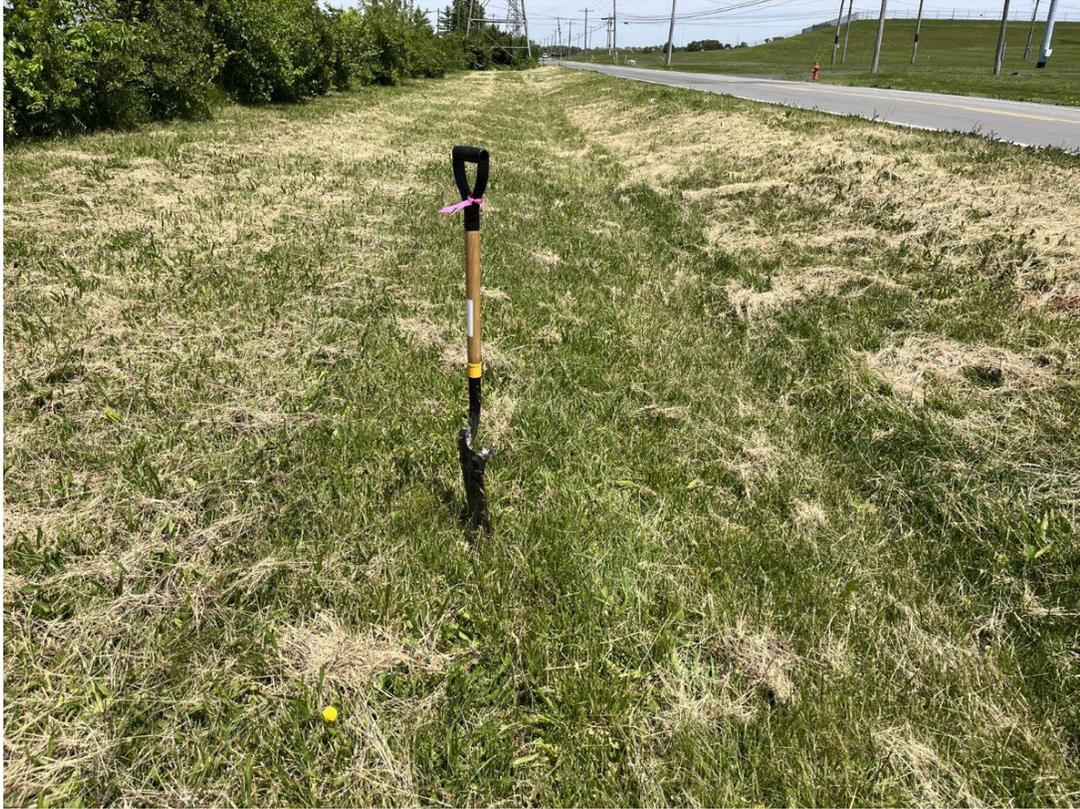
PHOTOGRAPH 5

Soil Test Pit STP-002, facing north on May 25, 2023.

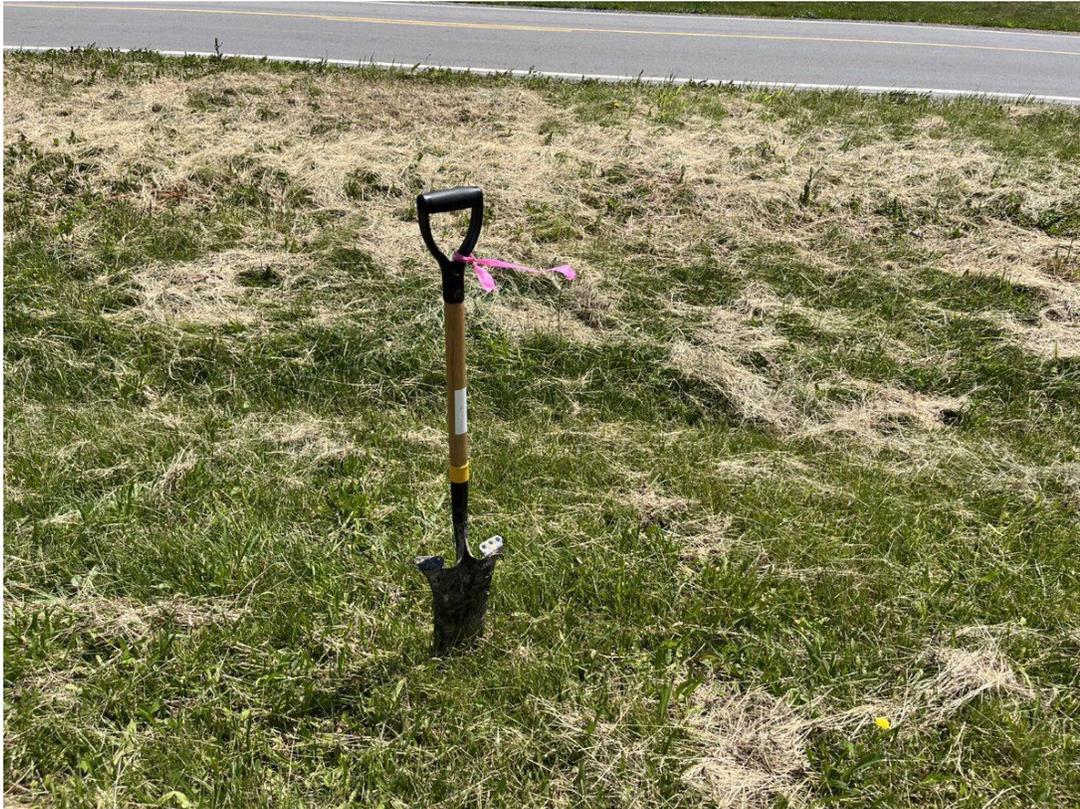
PHOTOGRAPH 7

Soil Test Pit STP-002, facing east on May 25, 2023.

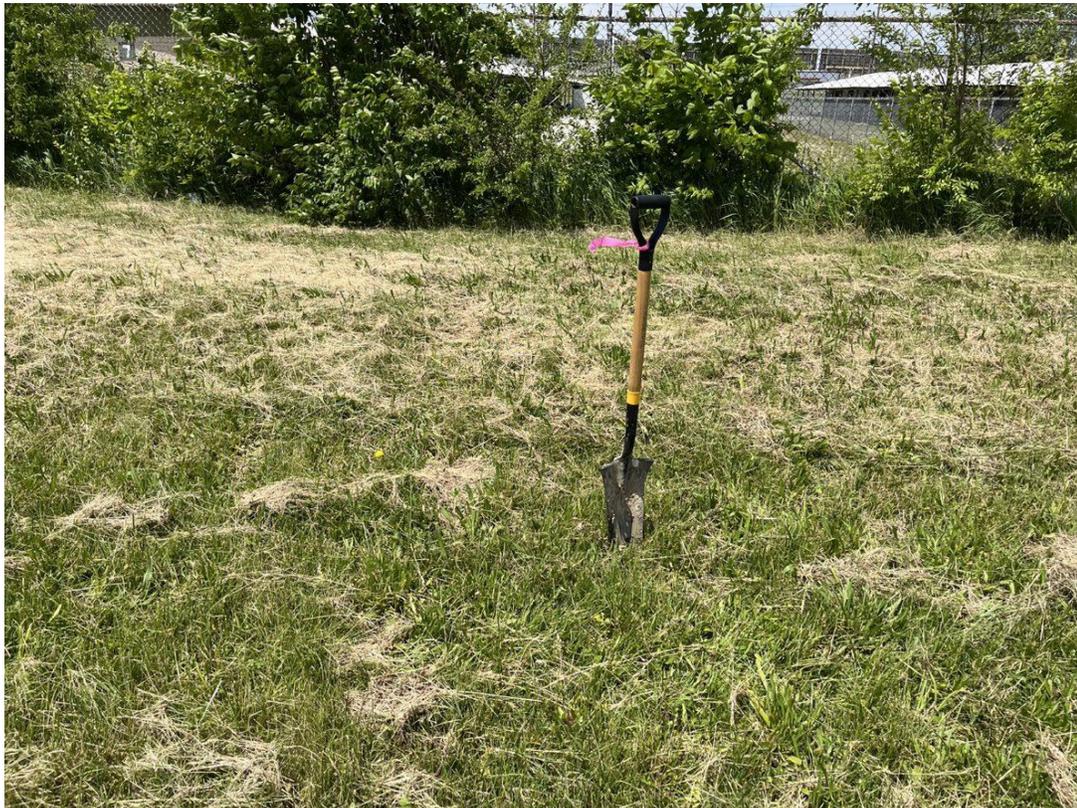
PHOTOGRAPH 8

Soil Test Pit STP-002, facing west on May 25, 2023.

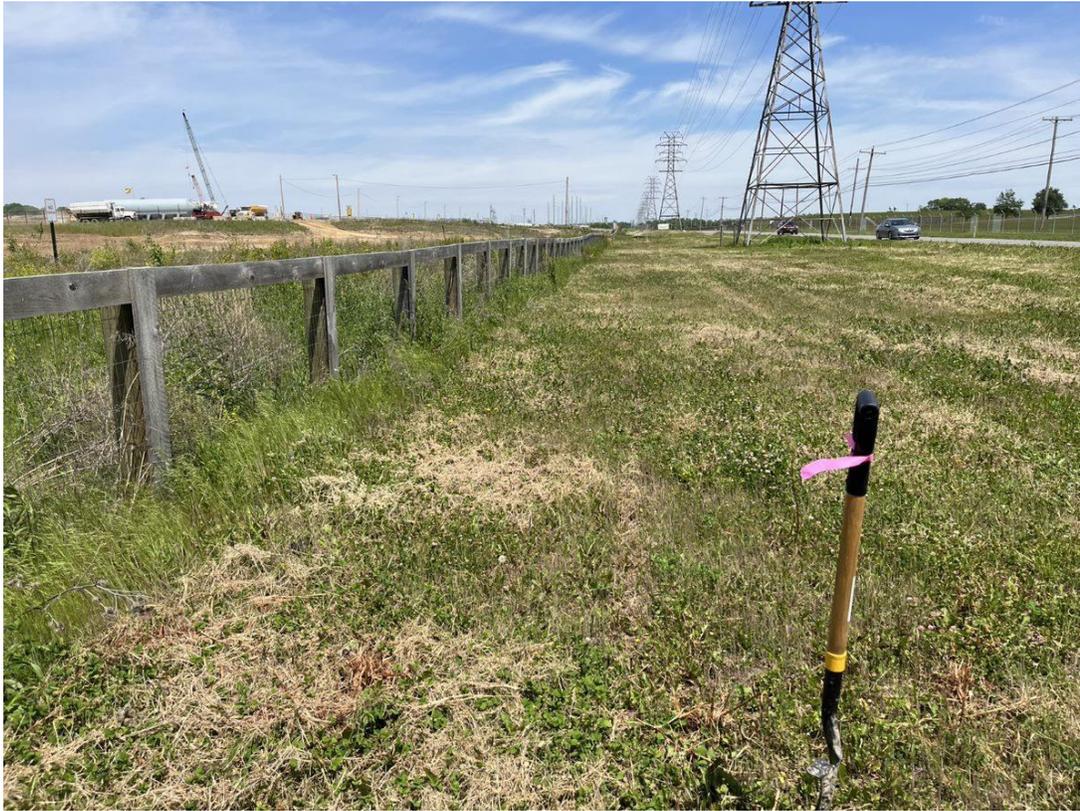
PHOTOGRAPH 9

Soil Test Pit STP-003, facing north on May 25, 2023.

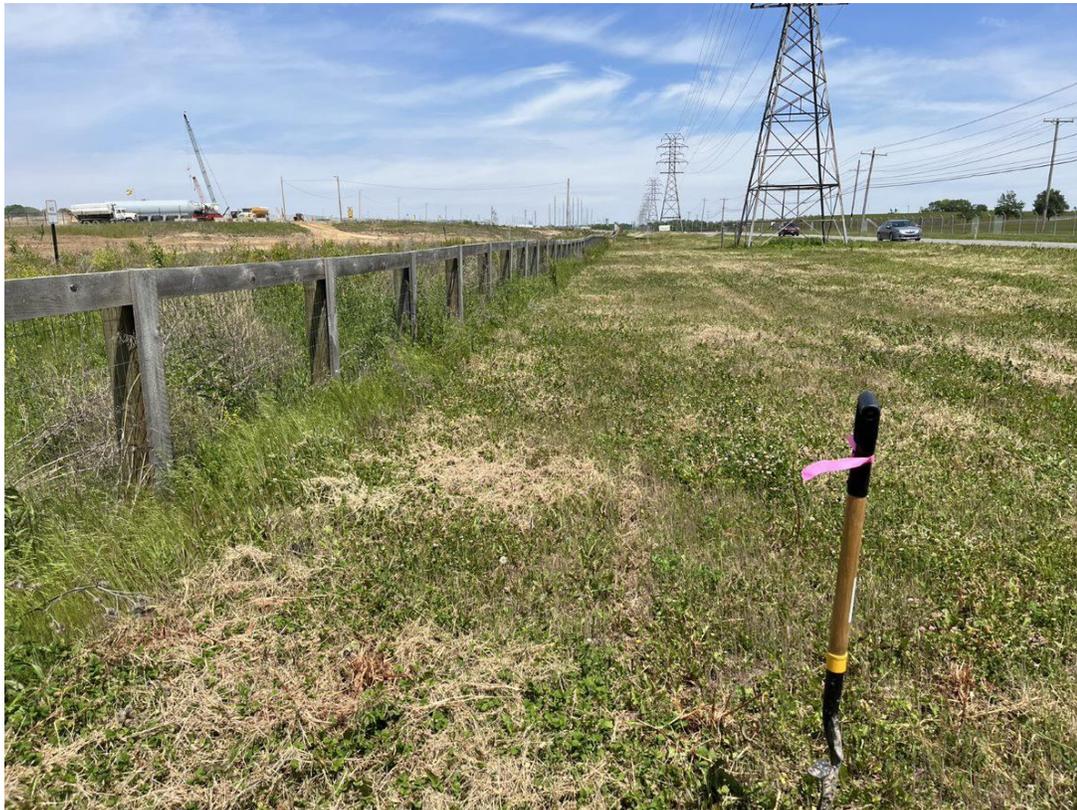
PHOTOGRAPH 10

Soil Test Pit STP-003, facing south on May 25, 2023.

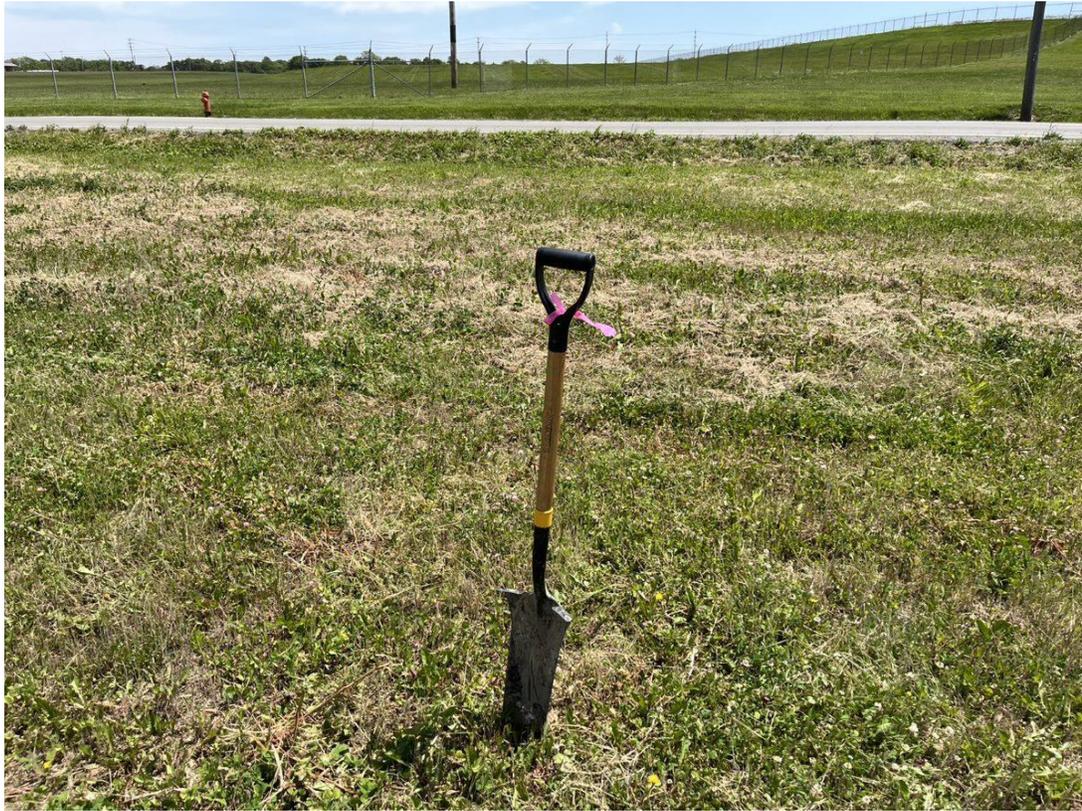
PHOTOGRAPH 11

Soil Test Pit STP-003, facing east on May 25, 2023.

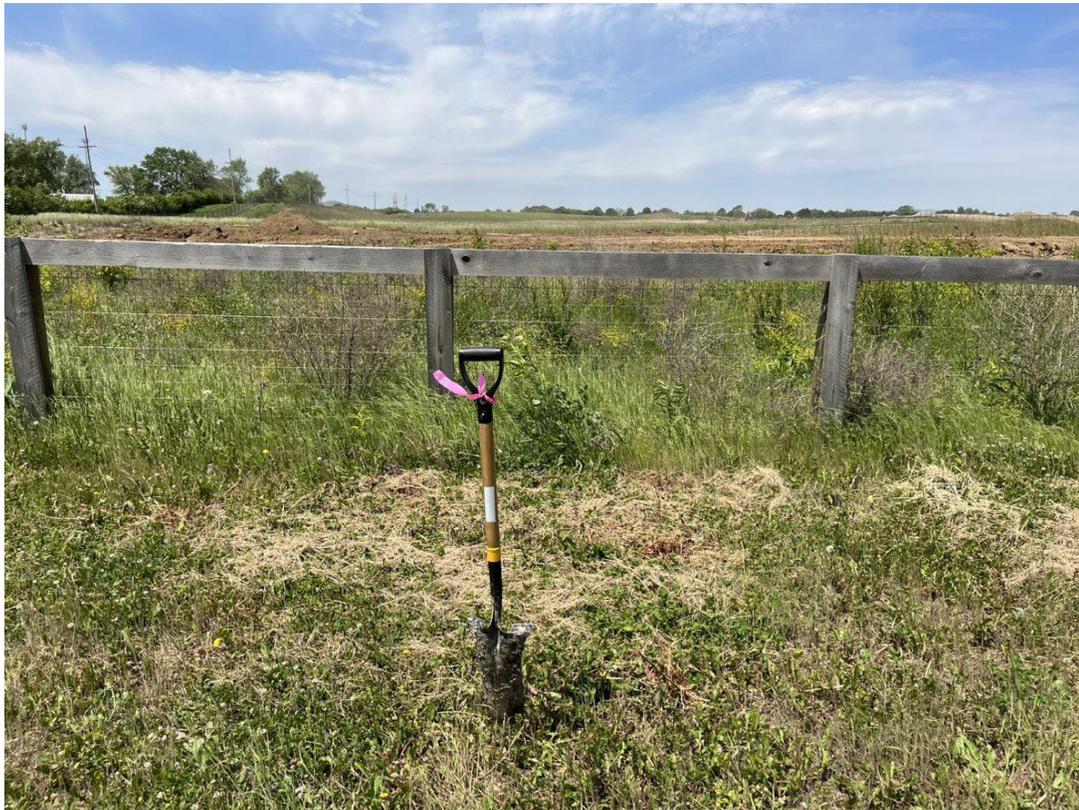
PHOTOGRAPH 12

Soil Test Pit STP-003, facing west on May 25, 2023.
